## **Historic Structure Assessment for Building 839, Carlisle Barracks**

Carlisle, Pennsylvania

October 2017

Final report

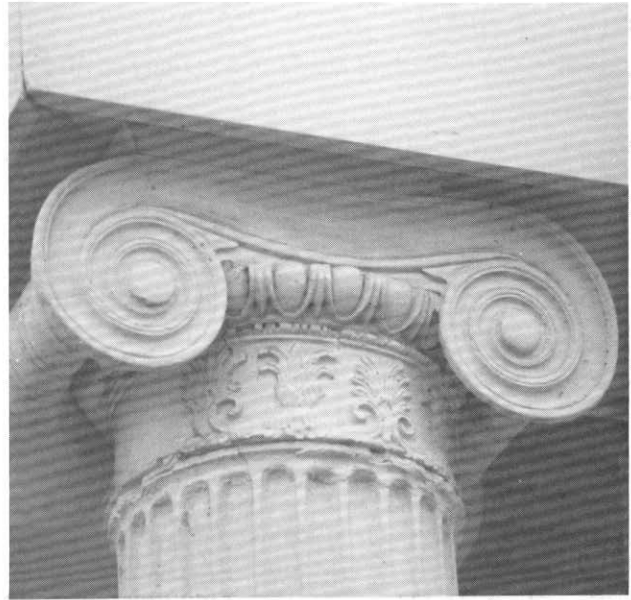
*This replica column capital was made using epoxy resins poured into a mold taken from the building. The historic wooden column shaft was repaired during the restoration. Photo: Courtesy Dell Corporation.*

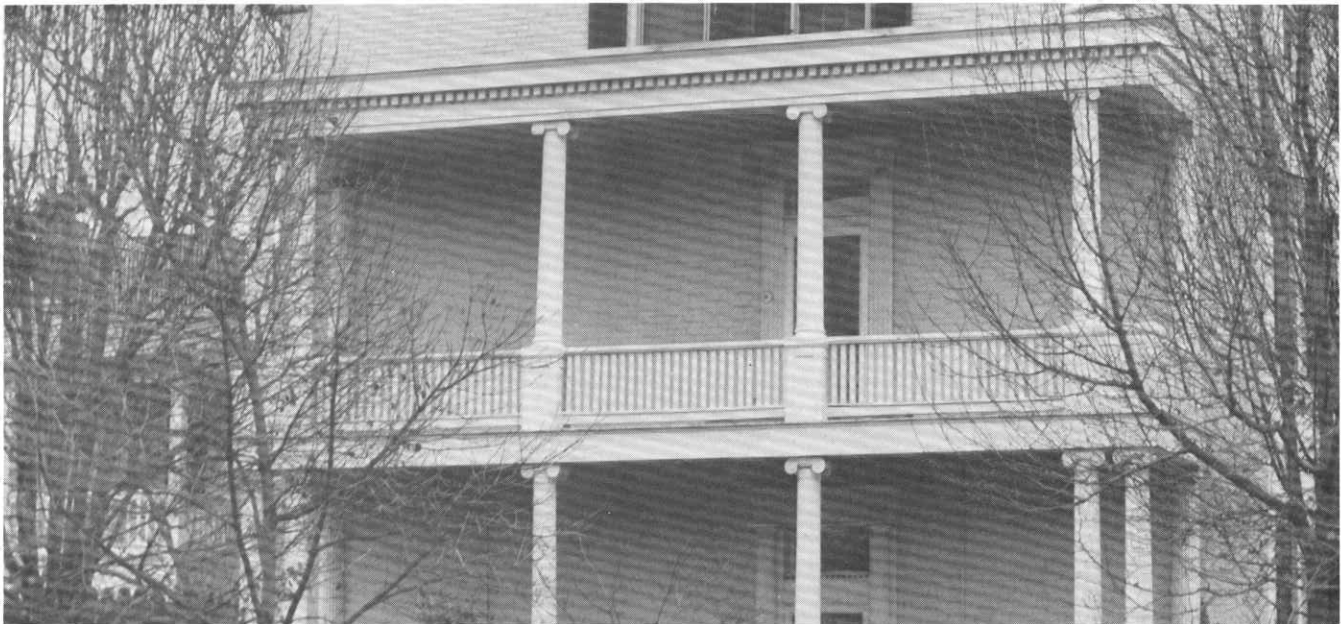
*Columns were repaired and a capital was replaced in epoxy on this 19th-century 2-story porch. Photo: Dell Corporation*

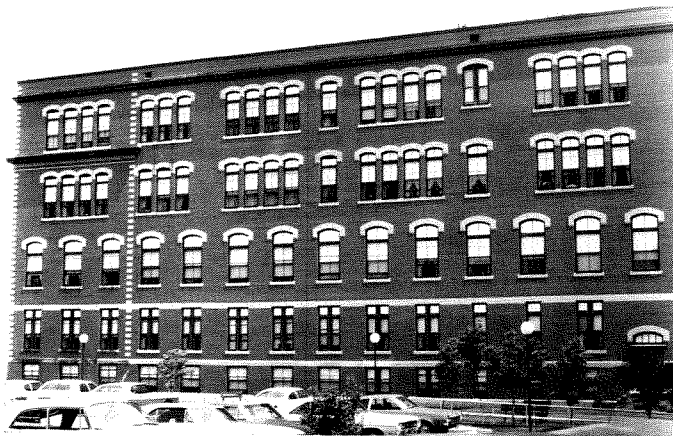
Window and door openings can be important to the overall visual character of historic buildings. This view shows only part of a much larger building, but the windows clearly help define its character, partly because of their shape and rhythm: the upper floor windows are grouped in a 4,3,4,1,4 rhythm, and the lower floor windows are arranged in a regular 1,1,1,... rhythm. The individual windows are tall, narrow and arched, and they are accented by the different colored arched heads, which are connected where there are multiple windows so that the color contrast is a part of its character. If additional windows were inserted in the gap of the upper floors, the character would be much changed, as it would if the window heads were painted to match the color of the brick walls. Photo by Susan I. Dynes

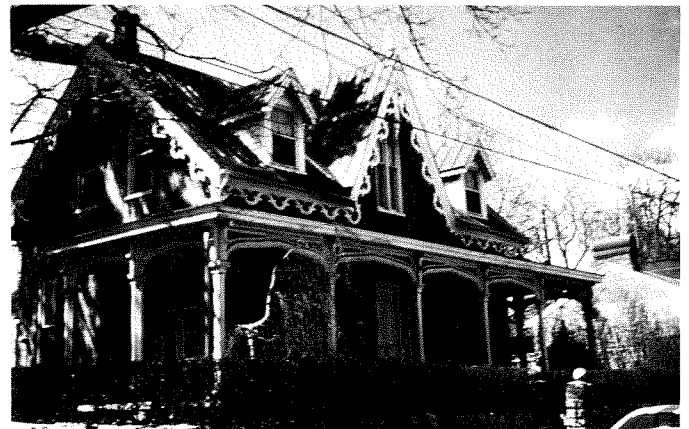
#### ***Overall Visual Character: Projections***

Many buildings have projecting features such as porches, bay windows, or overhanging roofs, that help define their overall visual character. This projecting porch because of its size and shape, and because it copies the pitch and material of the main roof, is an important contributor to the visual character of this simple farmhouse. The removal or alteration of this porch would drastically alter the character of this building. If the porch were enclosed with wood or glass, or if gingerbread brackets were added to the porch columns, if the tin roof was replaced with asphalt, or if the porch railing was opened to admit a center stairway, the overall visual character could be seriously damaged. Although this projecting porch is an important feature, almost any other change to this house, such as changes to the window pattern, or changes to the main roof, or changes to the setting, would also change its visual character. Photo by Hugh C. Miller

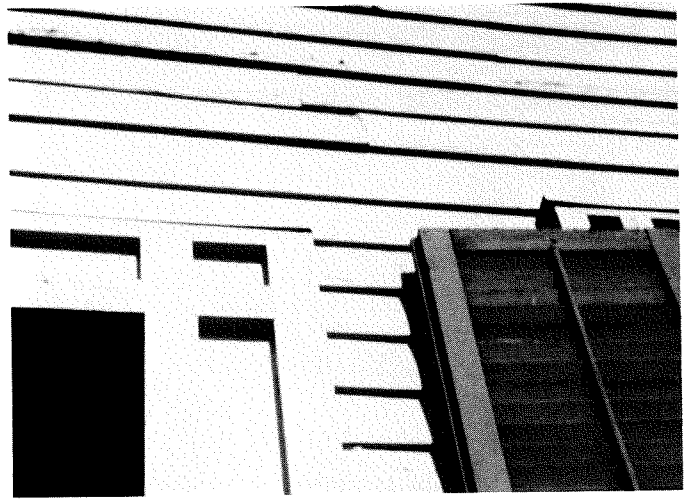
#### ***Arm's Length Visual Character: Craft Details***

On some buildings, there are subtle aspects of visual character that cannot be perceived from a distance. This is especially true of certain craft details that can be seen only at close range. On this building, it is easily understood that the narrow, unpainted, and weathered clapboards are an important aspect of its overall visual character; but at close range there are a number of subtle but very important craft details that contribute to the handmade quality of this building, and which clearly differentiate it from a building with machine sawn clapboards. The clapboards seen here were split by hand and the bottom edges were not dressed, so that the boards vary in width and thickness, and thus they give a very uneven shadow pattern. Because they were split from oak that is unpainted, there are occasional wavy rays in the wood that stand against the grain. Also noticeable is the fact that the boards are of relatively short lengths, and that they have feather-edged ends that overlap each other, a detail that is very different from butted joints. The occasional large nail heads and the differential silver-gray weathering add to the random quality of the clapboards. All of these qualities contribute to the arm's length visual character. Photo by Lee H. Nelson

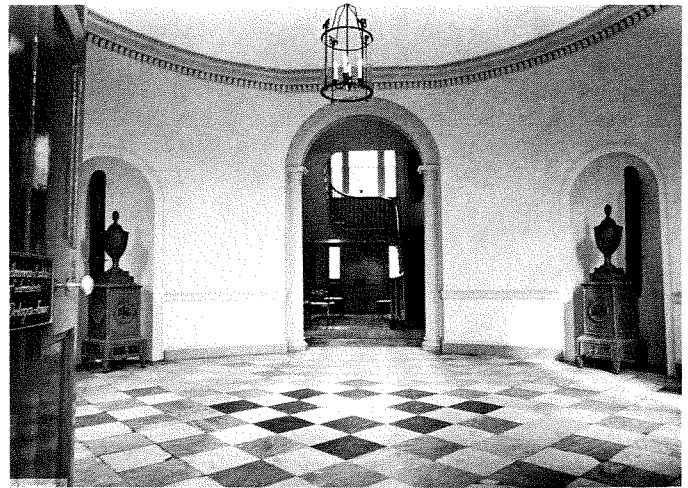
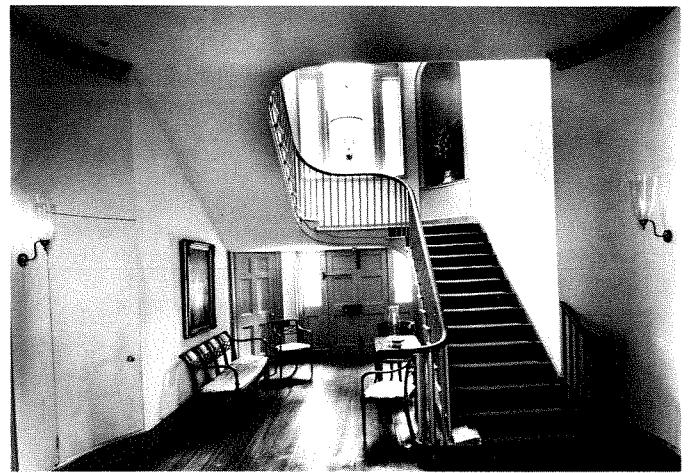
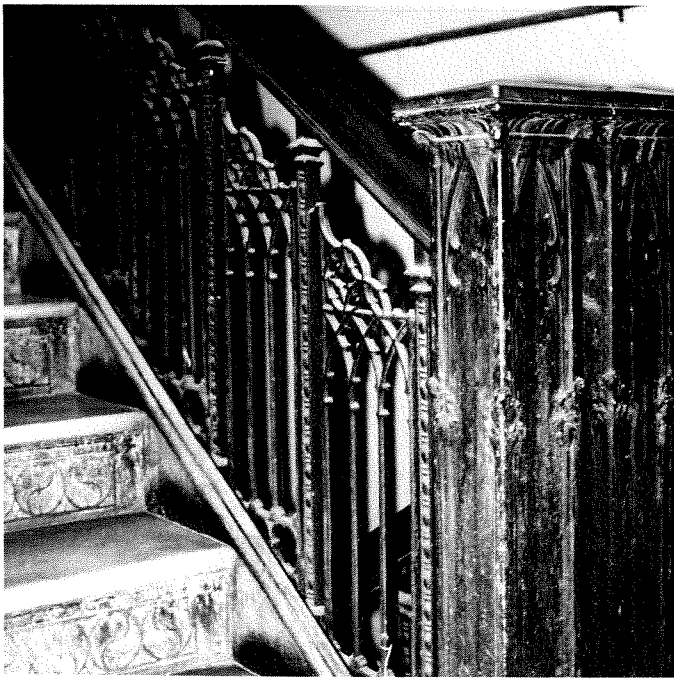
The stairway is the third part of this sequence of related spaces, and it provides continuing access to the upper floors.

These related spaces are very important in defining the interior character of this building. Almost any change to these spaces, such as installing doors between the vestibule and the hallway, or enclosing the stair would seriously impact their character and the way that character is perceived. Top photo by Mel Chamowitz, others by John Tennant

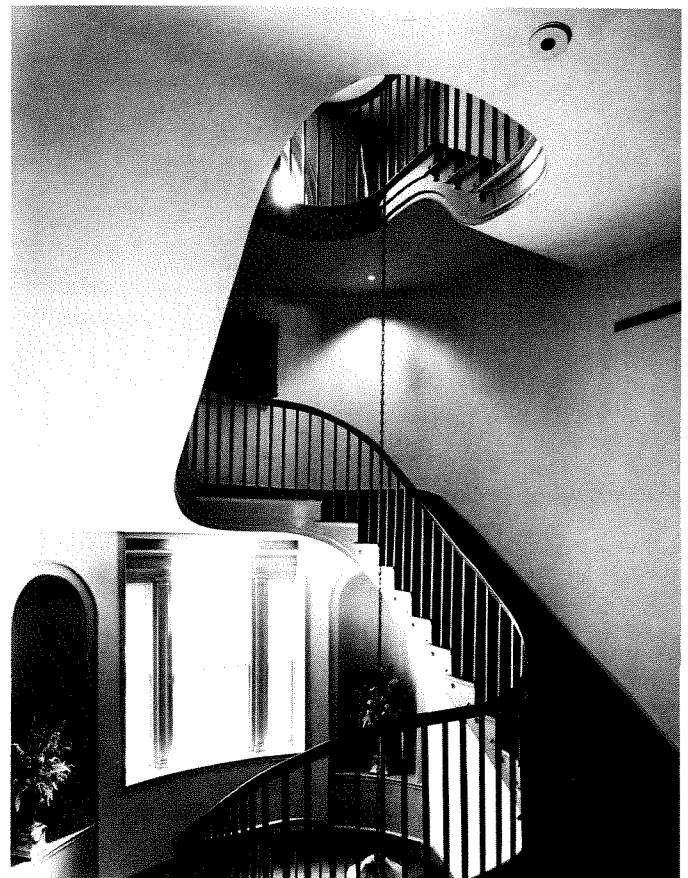
### ***Interior Visual Character: Interior Features***

Interior features are three-dimensional building elements or architectural details that are an integral part of the building as opposed to furniture. Interior features are often important in defining the character of an individual room or space. In some instances, an interior feature, like a large and ornamental open stairway may dominate the visual character of an entire building. In other instances, a modest iron stairway (like the one illustrated here) may be an important interior feature, and its preservation would be crucial to preserving the interior character of the building. Such features can also include the obvious things like fireplace mantles, plaster ceiling medallions, or panelling, but they also extend to features like hardware, lighting fixtures, bank tellers cages, decorative elevator doors, etc. Photo by David W. Look

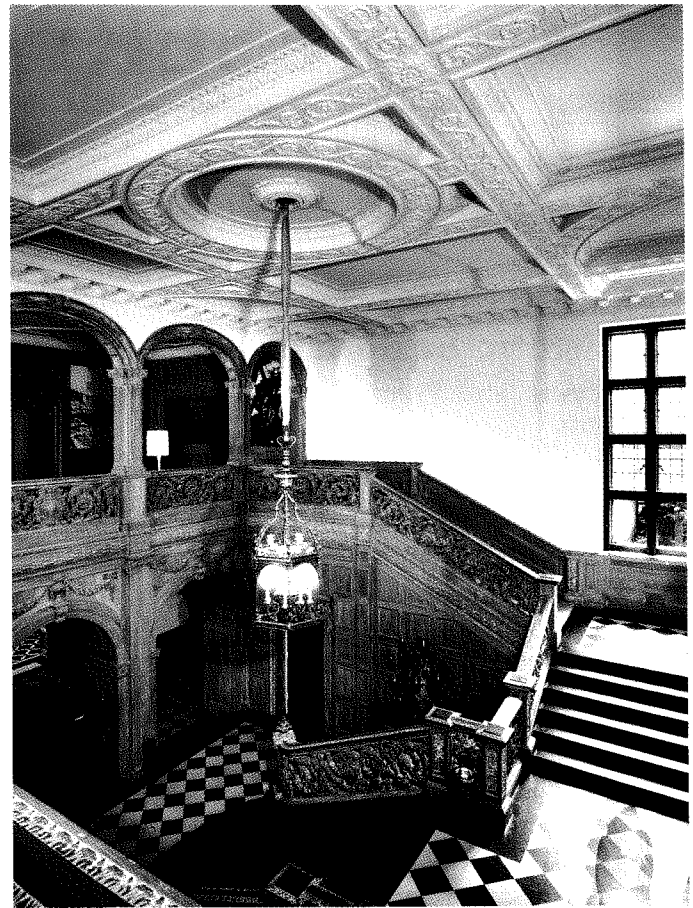
Figure 1. This architect-designed interior reflects early 20th century American taste: the checkerboard tile floor, wood wainscot, coffered ceiling, and open staircase are richly detailed and crafted by hand. Not only are the individual architectural features worthy of preservation, but the planned sequence of spaces—entry hall, stairs, stair landings, and loggia—imparts a grandeur that is characteristic of high style residences of this period. This interior is of Greystone, Los Angeles, California. Photography for HABS by Jack E. Boucher

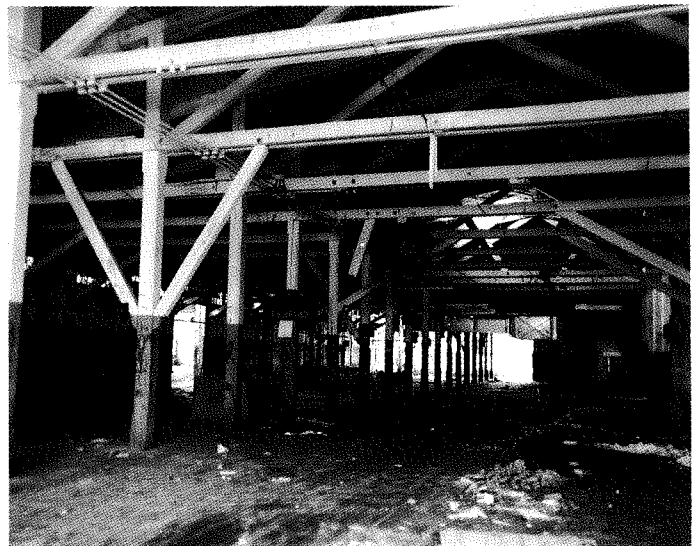
Figure 2. The interiors of mills and industrial buildings frequently are open, unadorned spaces with exposed structural elements. While the new uses to which this space could be put are many—retail, residential, or office—the generous floor-to-ceiling height and exposed truss system are important character-defining features and should be retained in the process of rehabilitation.

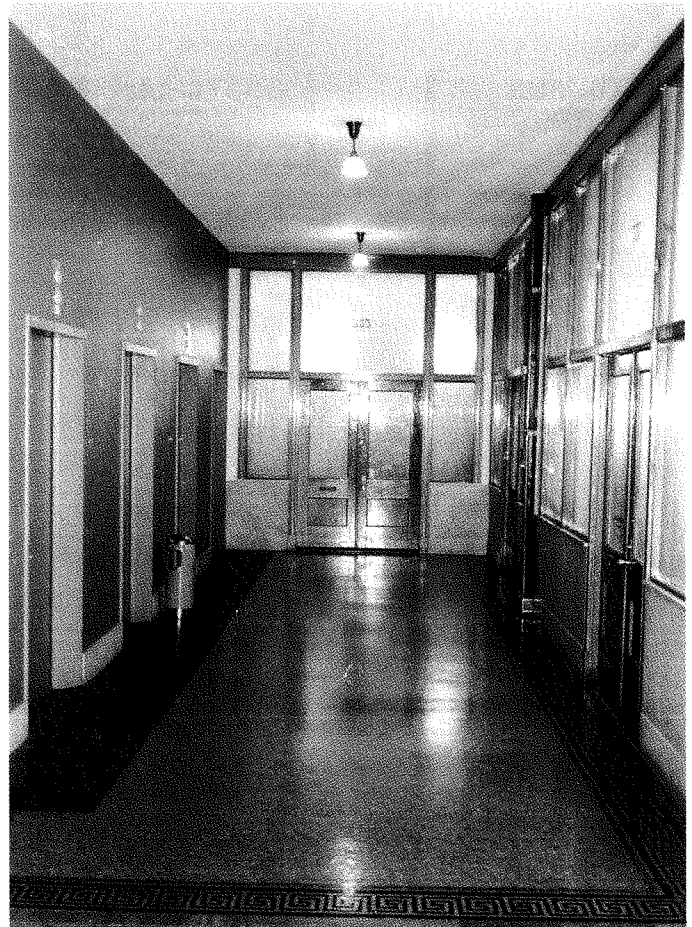
Figure 6. This corridor, located in the historic Monadnock Building in Chicago, has glazed walls, oak trim, and marble wainscoting, and is typical of those found in late 19th and early 20th century office buildings. Despite the simplicity of the features, a careful attention to detail can be noted in the patterned tile floor, bronze mail chute, and door hardware. The retention of corridors like this one should be a priority in rehabilitation projects involving commercial buildings.

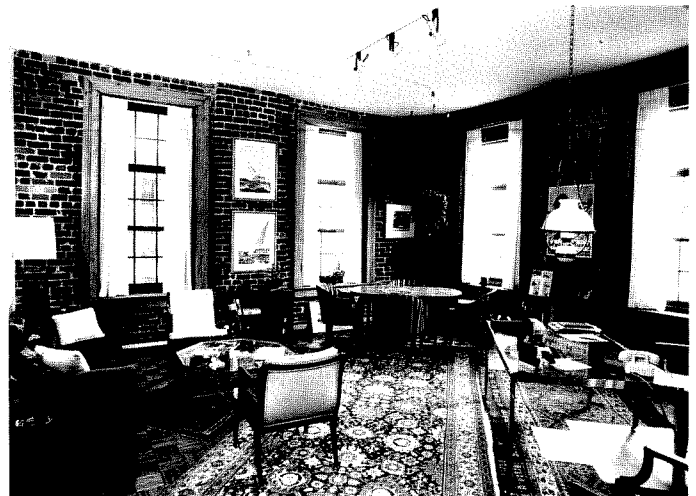
Figure 10. In this case plaster has been removed from perimeter walls, leaving brick exposed. In removing finishes from historic masonry walls, not only is there a loss of historic finish, but raw, unfinished walls are exposed, giving the interior an appearance it never had. Here, the exposed brick is of poor quality and the mortar joints are wide and badly struck. Plaster should have been retained and repaired, as necessary.

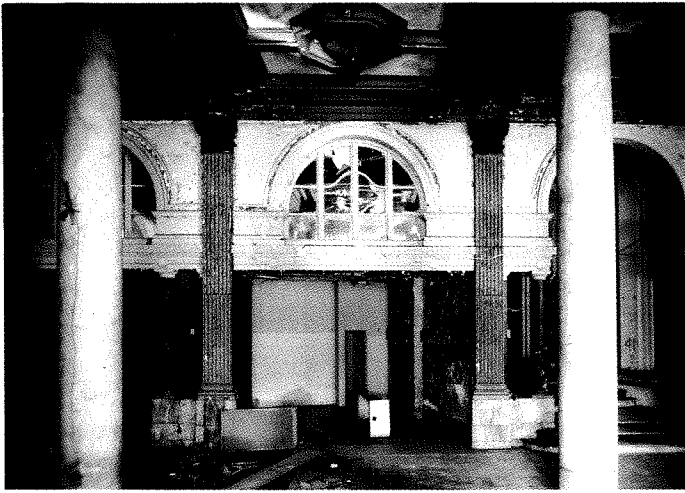
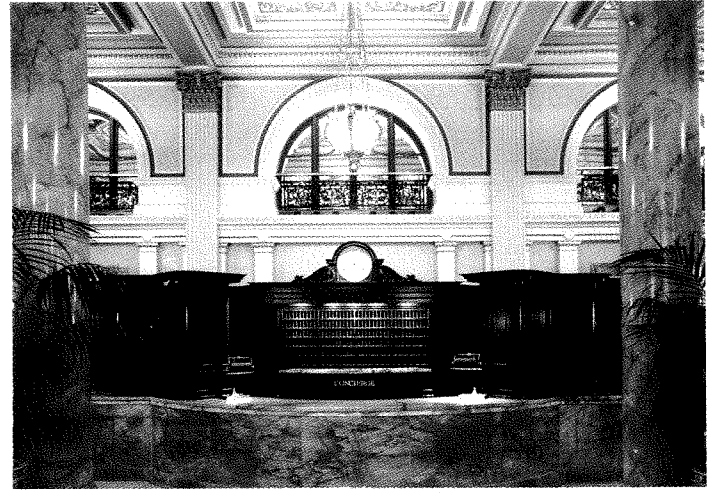
Figure 11. These dramatic “before” and “after” photographs show a severely deteriorated space restored to its original elegance: plaster has been repaired and painted, the scagliola columns have been restored to match marble using traditional craft techniques, and missing decorative metalwork has been re-installed in front of the windows. Although some reorganization of the space took place, notably the relocation of the front desk, the overall historic character of the space has been preserved. These views are of the lobby in the Willard Hotel, Washington, D.C. Credit: Commercial Photographers (left); Carol M. Highsmith (right)

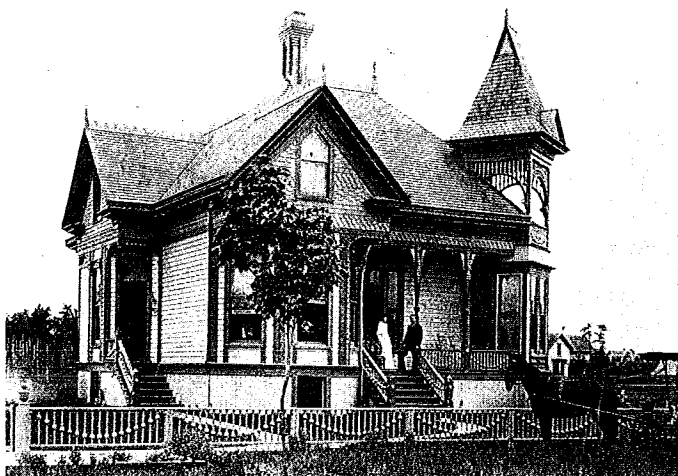
3. Readily available and inexpensive sawn shingles were used not only for roofs, but also for gables and wall surfaces. The circa 1891 Chambers House, Eugene, Oregon used straight sawn butts for the majority of the roof and hexagonal butts for the lower portion of the corner tower. Decorative shingles in the gable ends and an attractive wooden roof cresting feature were also used. Photo: Lane County Historical Society.

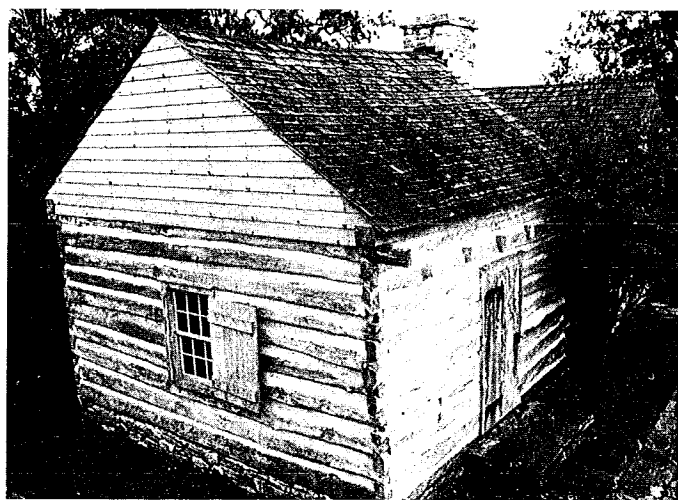
2. Handsplit and dressed shingles were also used on less elaborate buildings as seen in the restoration of the circa 1840 kitchen at the Winedale Inn, Texas. The uneven surfaces of the handsplit shingles were generally dressed or smoothed with a draw-knife to keep the rainwater from collecting in the wood grain and to ensure that the shingles lay flat on the sub-roof. Photo: Thomas Taylor.

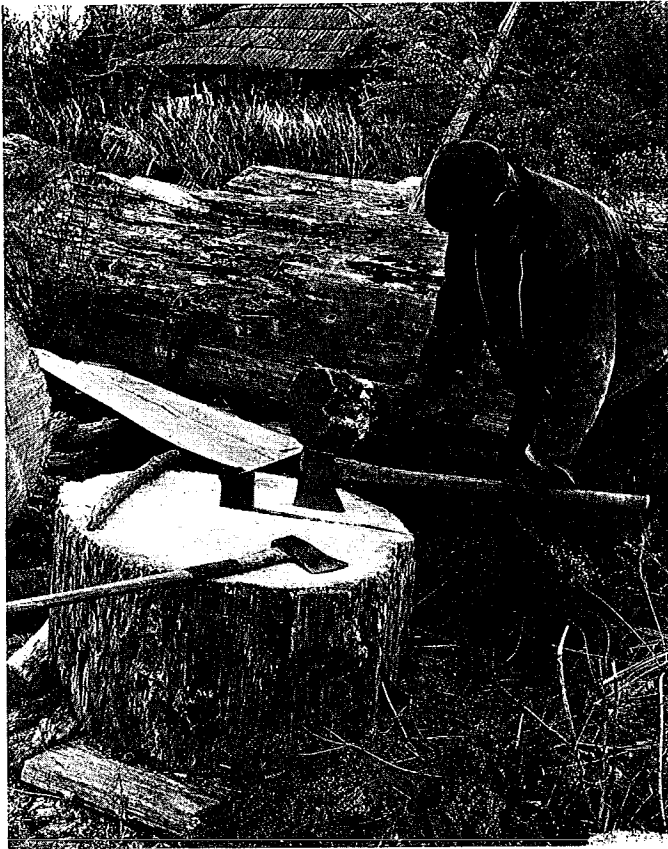
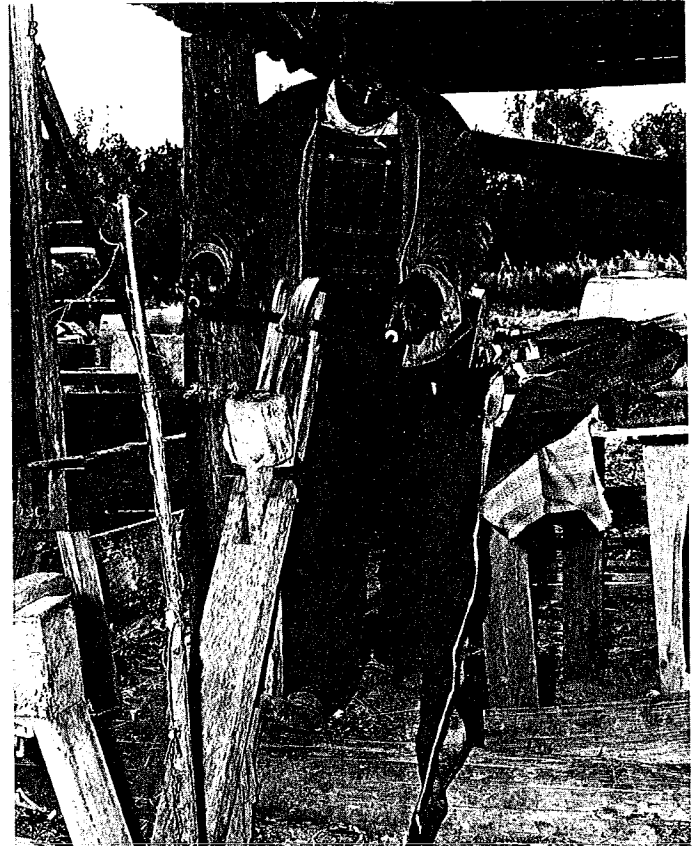
5. Custom Handsplit shingles are still made the traditional way with a mallet and froe or ax. For these cypress shingles, a "bolt" section of log (photo A) the length of the shingle has been sawn and is ready to be split into wedge-shaped segments. Handsplit shingles are fabricated with the ax or froe cutting the wood along the grain and separating, or riving, the shingle away from the remaining wedge. The rough surfaces are dressed on a shavinghorse using a draw-knife as shown above (photo B). Note the long wooden shingles covering the work shed in photo A. Photos: Al Honeycutt, North Carolina Division of Archives and History.

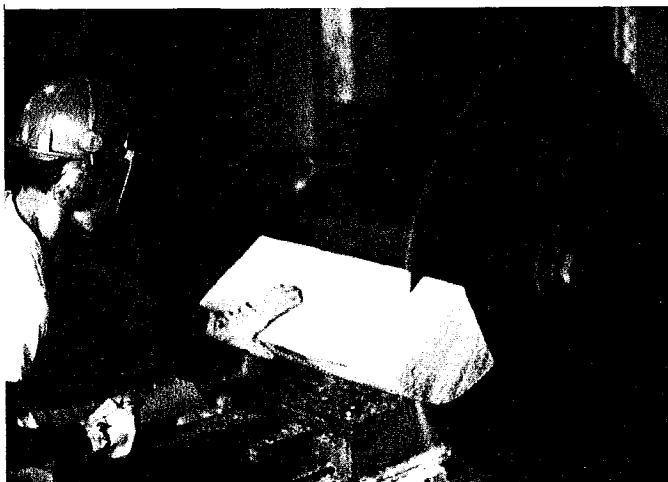
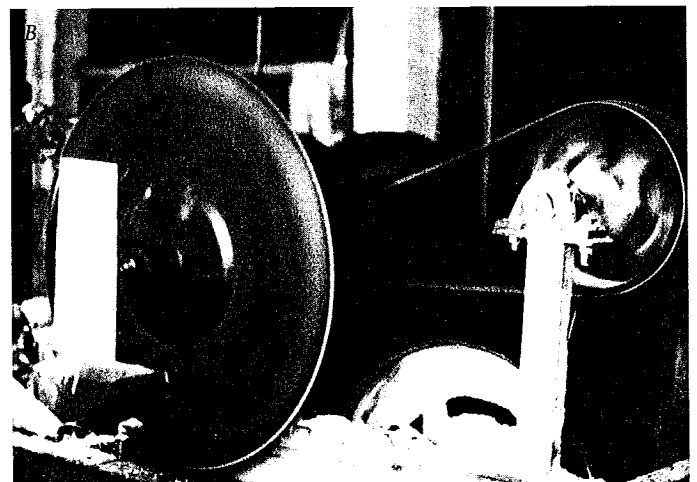
6. Modern machine-made shingles are sawn. Shown are: (photo A) Eastern White Pine quarter split shingle block on equalizer saw being trimmed to parallel the ends; and (photo B) the restored 19th-century shingle mill saw cutting tapered flitches or shingles. The thickness and taper can be precisely controlled. Photo: Steve Ruscio, The Shingle Mill.

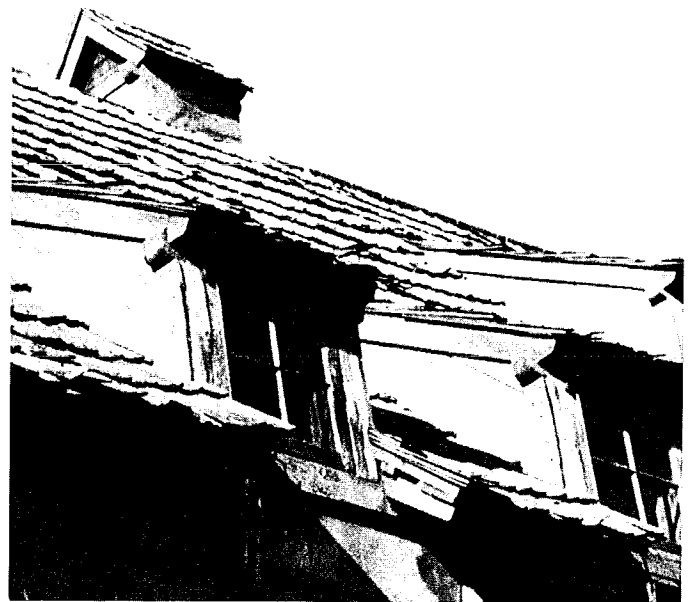
8. The long biaxially tapered handsplit shingles on the Ephrata Cloisters in Pennsylvania were overlapped both vertically and horizontally. The insert sketch shows channels under the shingles that provided ventilation and drainage of any trapped moisture. The aged appearance of these handsplit and dressed shingles belies their original smoothness. Replacement shingles should match the original, not the aged appearance. Photo: National Park Service; Sketch: Reed Engle.

Not all shingles were laid in evenly spaced, overlapping, horizontal rows. In various regions of the country, there were distinct installation patterns; for example, the biaxially-tapered long shingles occasionally found in areas settled by the Germans (see illus. 8). These long shingles were overlapped on the side as well as on top. This formed a ventilation channel under the shingles that aided drying. Because ventilation of the shingles can prolong their life, roofers paid attention to these details (see illus. 9).

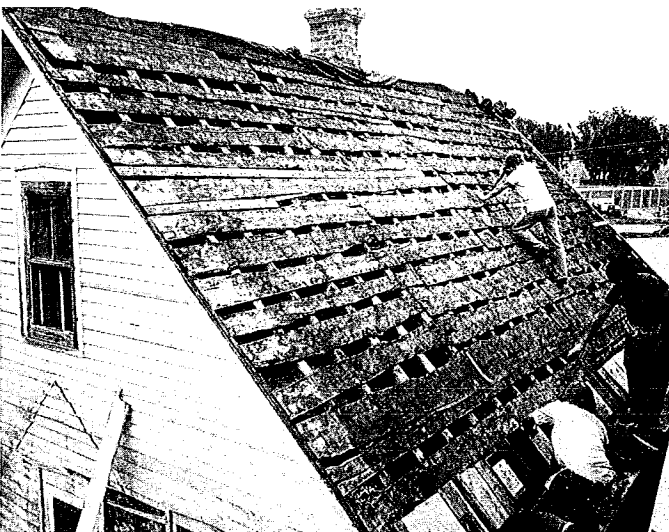
7. The reshingling of the circa 1856 Stovewood House in Decorah, Iowa, revealed the original open sheathing boards and pole rafters. Sawn cedar shingles were used as a replacement for the historic cedar shingles seen still in place at the ridge. A new starter course is being laid at the eaves. Photo: Norwegian-American Museum, Decorah, Iowa.

In order to have a weathertight roof, it was important to have adequate coverage, proper spacing of shingles, and straight grain shingles. Many roofs were laid on open shingle lath or open sheathing boards (see illus. 7). Roofers typically laid three layers of shingles with approximately 1/3 of each shingle exposed to the weather. Spaces between shingles (1/8"–1/2" depending on wood type) allowed the shingles to expand when wet. It was important to stagger each overlapping shingle by a minimum of 1-1/2" to avoid a direct path for moisture to penetrate a joint. Doubling or tripling the starter course at the eave gave added protection to this exposed surface. In order for the roof to lay as flat as possible, the thickness, taper and surface of the shingles was relatively uniform; any unevenness on handsplit shingles had already been smoothed away with a drawknife. To keep shingles from curling or cupping, the shingle width was generally limited to less than 10".

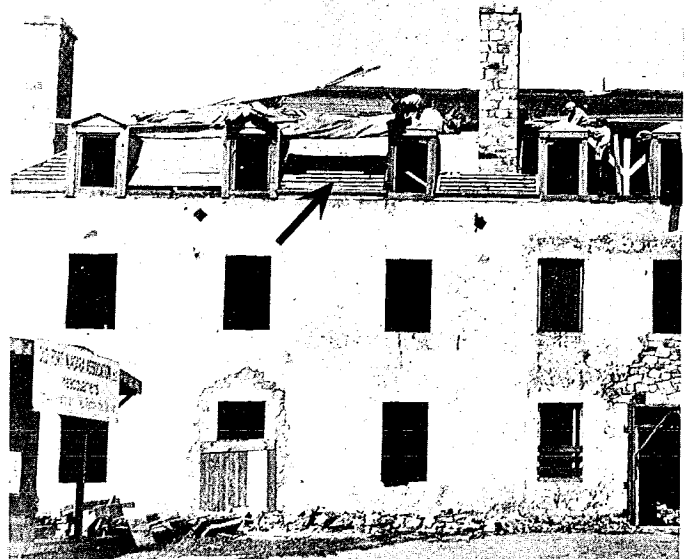
9. This 1927 view of the reshingling of the French Castle at Old Fort Niagara, N.Y., shows the wooden sleepers being laid (see arrow) over solid sheathing in order to raise the shingles up slightly to allow under-shingle ventilation. Note that the horizontal strips are not continuous to allow airflow and trapped moisture to drain away. This cedar roof has lasted for over 60 years in a harsh moist environment. Photo: Old Fort Niagara, Assoc. Inc.

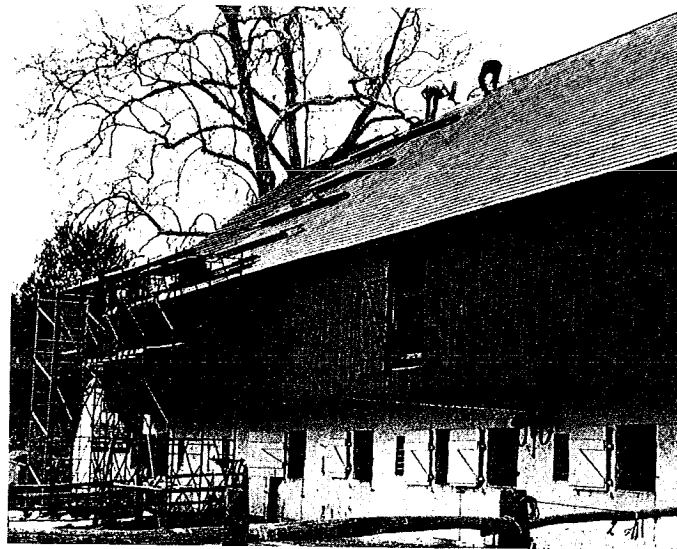
11. The replacement sawn red cedar shingles matched the deteriorated shingles exactly for this barn re-roofing. The old shingles, seen to the far left, were removed as the new shingles were installed. Even the horizontal coursing matched because the exposure length for both old and new shingles was the same. Photo: Williamsport Preservation Training Center.

mation regarding the early shingles used. Before specifying a replacement roof, it is important to *establish the original shingle material, configuration, detailing and installation* (see illus. 11). If the historic shingles are still in place, it is best to remove several to determine the size, shape, exposure length, and special features from the unweathered portions. If there are already replacement shingles on the roof, it may be necessary to verify through photographic or other research whether the shingles currently on the roof were an accurate replacement of the historic shingles.

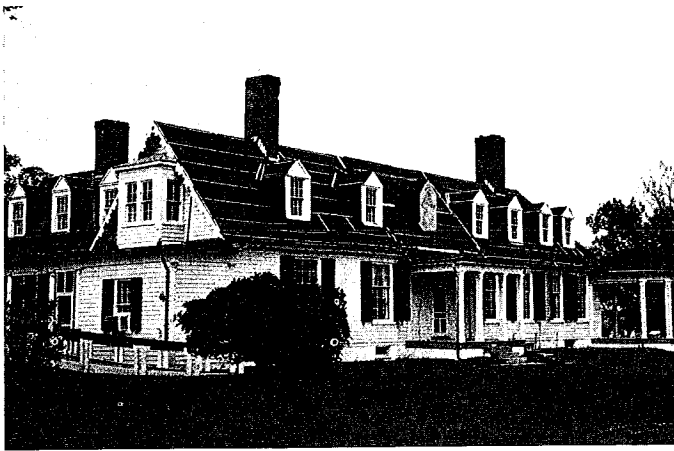
A. The later non-historic shingles were removed from Appomattox Manor (circa 1840 with later additions) and roofing paper was installed for temporary protection during the re-shingling.

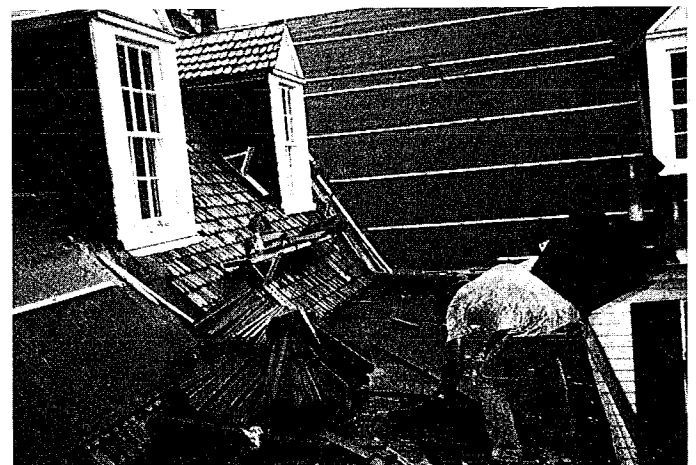
C. The replacement shingles (see specifications above), matched the historic shingles and were of such high quality that little hand dressing was needed at the site. The building paper, a temporary protection, was removed as the shingles were installed on the sheathing boards.

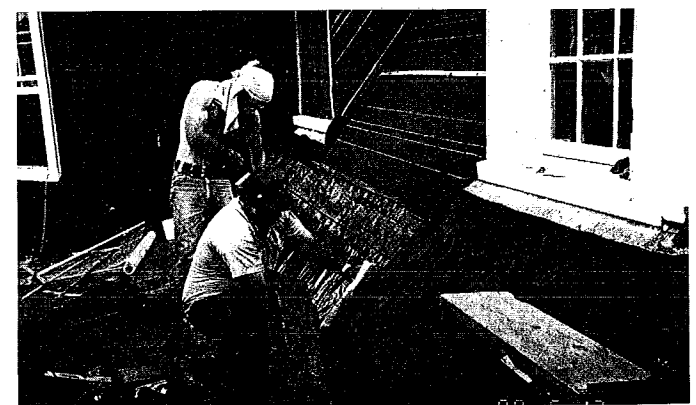
E. In order to achieve a "Class B" fire-rating, the shingles were dipped in fire-retardant chemicals and allowed to dry prior to installation. Iron oxide was added to this chemical dip to stain the shingles to match the historic red color. These coatings will need periodic reapplication.

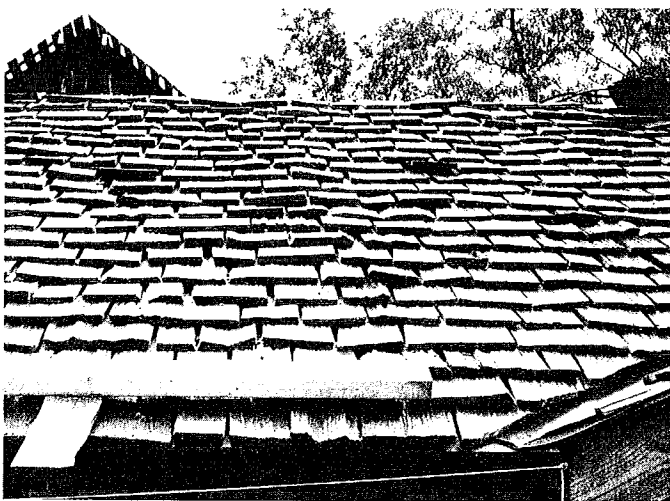
15. These commercially available roofing products with rustic split faces are not appropriate for historic preservation projects. In addition to the inaccurate appearance, the irregular surfaces and often wide spaces between shingles will allow wind-driven moisture to penetrate up and under them. The excessively wide boards will tend to cup, curl and crack. Moss, lichens and debris will have a tendency to collect on these irregular surfaces, further deteriorating the roofing. Photo: Sharon C. Park.

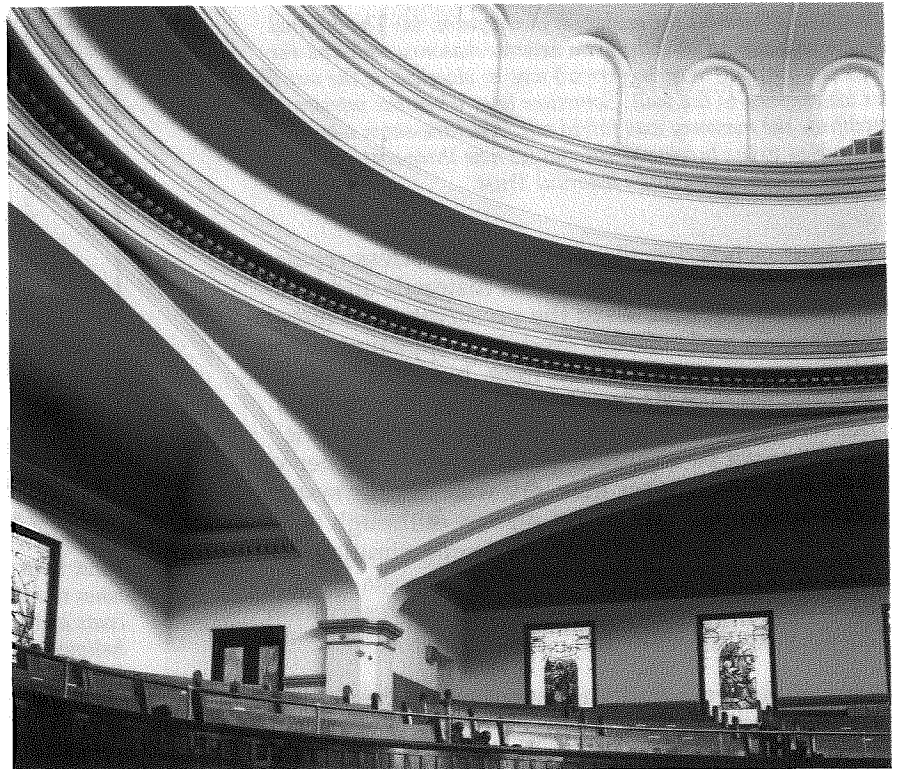
Fig. 1. Left: Schifferstadt, Frederick, Maryland, 1756. Right: First Christian Church, Eugene, Oregon, 1911. Although these two structures are separated in history by over 150 years and differences in size, ethnic origin, geography, construction techniques, and architectural character, their builders both used plaster as the interior surface coating for flat and curved walls. Photo left: Kay Weeks. Photo right: Kaye Ellen Simonson.

Plaster could be treated in any number of ways: it could receive stenciling, decorative painting, wallpaper, or whitewash. This variety and the adaptability of the material to nearly any building size, shape, or configuration meant that plaster was the wall surface chosen for nearly all buildings until the 1930s or 40s (Fig. 1).

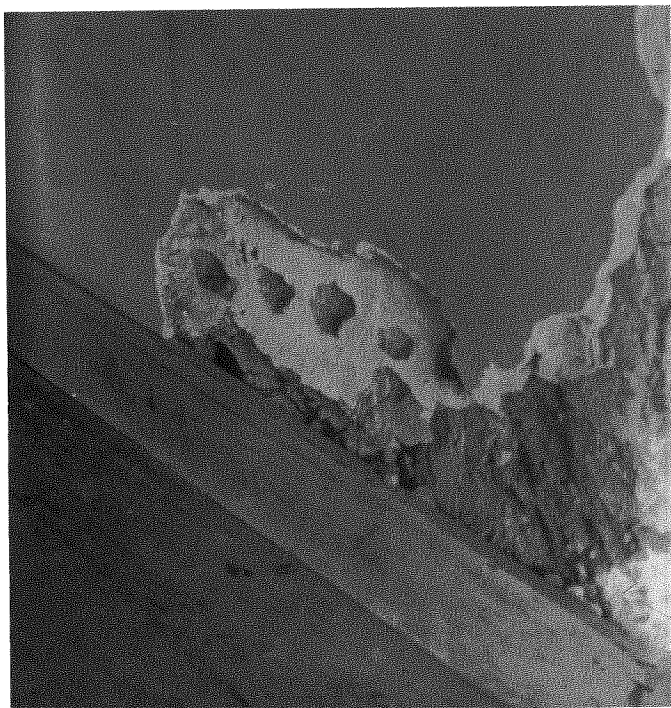
Fig. 4. The builders of this mid-18th century house installed the baseboard moulding first, then applied a mud and horse hair plaster (called *paling*) to the masonry wall. Lime was used for the finish plaster. Also shown are the hacking marks which prepared the wall for a subsequent layer of plaster. Photo: Kay Weeks.

Not only did the basic plastering material change, but the method of application changed also. In early America, the windows, doors, and all other trim were installed before the plaster was applied to the wall (Fig. 4). Generally the woodwork was prime-painted before plastering. Obtaining a plumb, level wall, while working against built-up mouldings, must have been difficult. But sometime in the first half of the 19th century, builders began installing wooden plaster “grounds” around windows and doors and at the base of the wall. Installing these grounds so that they were level and plumb made the job much easier because the plasterer could work from a level, plumb, straight surface. Woodwork was then nailed to the “grounds” after the walls were plastered (Fig. 5). Evidence of plaster behind trim is often an aid to dating historic houses, or to discerning their physical evolution.

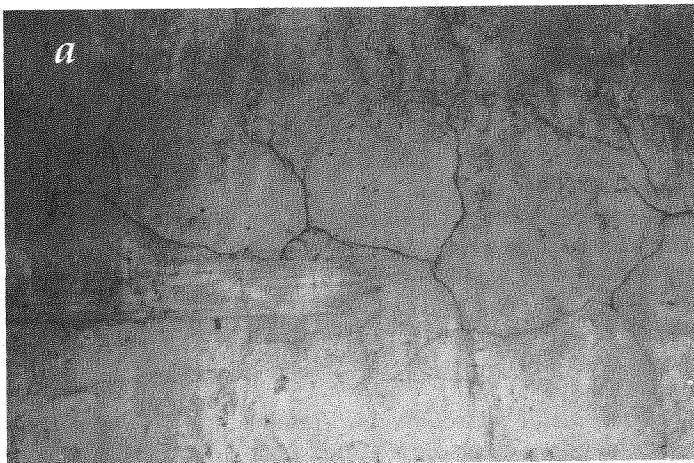
Fig. 7 (a) to (d). A series of photographs taken in different rooms of an early 20th century house in West Virginia reveal a variety of plaster wall surface problems, most of which can easily be remedied through sensitive repair: Hairline cracks (a) in an otherwise sound wall can be filled with joint compound or patched plaster. The wall can also be canvassed or wallpapered. Stress cracks (b) in plaster over a kitchen door frame can be repaired using fiberglass mesh tape and joint compound. Settlement cracks (c) in a bedroom can be similarly repaired. The dark crack at the juncture between walls, however, may be a structural crack and should be investigated for its underlying cause. Moisture damage (d) from leaking plumbing on the second floor has damaged both wallpaper and plaster in the dining room. After fixing the leaking pipes, the wall covering and rotted plaster will need to be replaced and any holes repaired. Photos: Kay Weeks.

When plaster dries, it is a relatively rigid material which should last almost indefinitely. However, there are conditions that cause plaster to crack, effloresce, separate, or become detached from its lath framework (Fig. 7). These include:

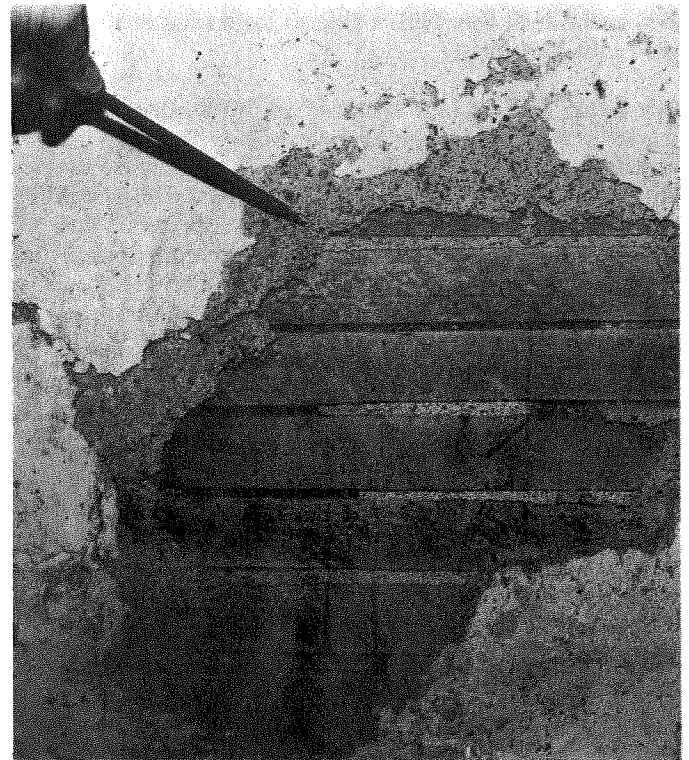
Fig. 8. Too much aggregate (sand) and not enough cementing material (lime or gypsum) in the base coat has made this plaster surface weak and crumbly. Besides losing its key with the lath, the layers are disintegrating. It will most likely need to be totally removed and replaced with all new plaster. Photo: Marylee MacDonald.

cheaper material. Oversanding can cause the plaster to weaken or crumble (Fig. 8). Plaster made from a poorly proportioned mix may be more difficult to repair.

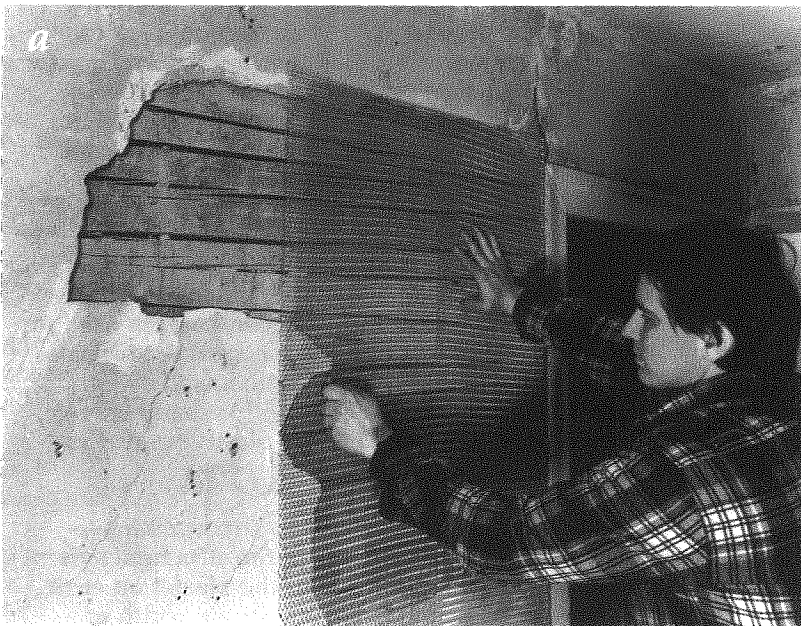
Fig. 10 (a) and (b). In this New Hampshire residence dating from the 1790s, the original plaster was a single coat of lime, sand, and horsehair applied over split lath. A one-coat repair, in this case, is appropriate. To the left: a flat sheet of galvanized expanded metal lath is placed over the patch area and an outline marked with a large soft lumber crayon. The metal lath is then cut to fit the hole and nailed to the lath. To the right: the edges of the original plaster and wood lath beneath have been thoroughly soaked with water. A steel trowel is used to apply the plaster in large, rough strokes. Finally, it will be scraped and smoothed off. Because only one coat of plaster is used, without a finish coat, a clean butt-joint is made with the original plaster. Photos: John Leeke.

For small holes (less than 4 inches in diameter) that involve loss of the brown and finish coats, the repair is made in two applications. First, a layer of basecoat plaster is troweled in place and scraped back below the level of the existing plaster. When the base coat has set but not dried, more plaster is applied to create a smooth, level surface. One-coat patching is not generally recommended by plasterers because it tends to produce concave surfaces that show up when the work is painted. Of course, if the lath only had one coat of plaster originally, then a one-coat patch is appropriate (Fig. 10).

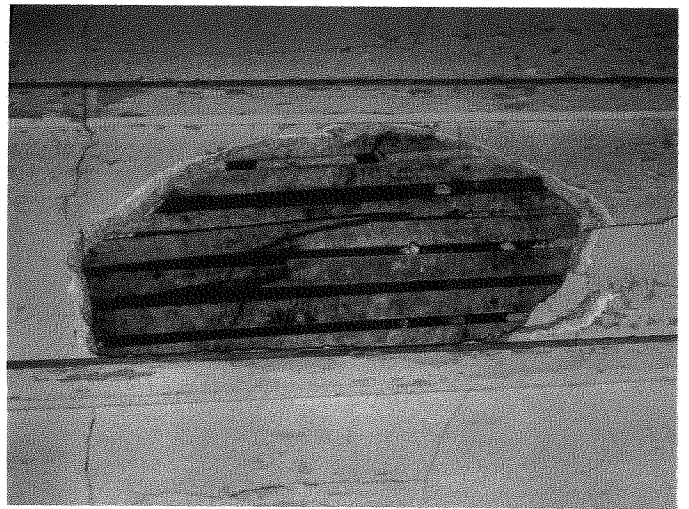
Fig. 13. This beaded ceiling in one of the bedrooms of the 1847 Lockwood House, Harpers Ferry, West Virginia, is missing portions of plaster due to broken keys. This is attributable, in part, to deterioration of the wood lath. Photo: Kaye Ellen Simonson.

Hairline cracks and holes may be unsightly, but when portions of the ceiling come loose, a more serious problem exists (Fig. 13). The keys holding the plaster to the ceiling have probably broken. First, the plaster around the loose plaster should be examined. Keys may have deteriorated because of a localized moisture problem, poor quality plaster, or structural overloading; yet, the surrounding system may be intact. If the areas surrounding the loose area are in reasonably good condition, the loose plaster can be reattached to the lath using flat-head wood screws and plaster washers (Fig. 14). To patch a hole in the ceiling plaster, metal lath is fastened over the wood lath; then the hole is filled with successive layers of plaster, as described above.

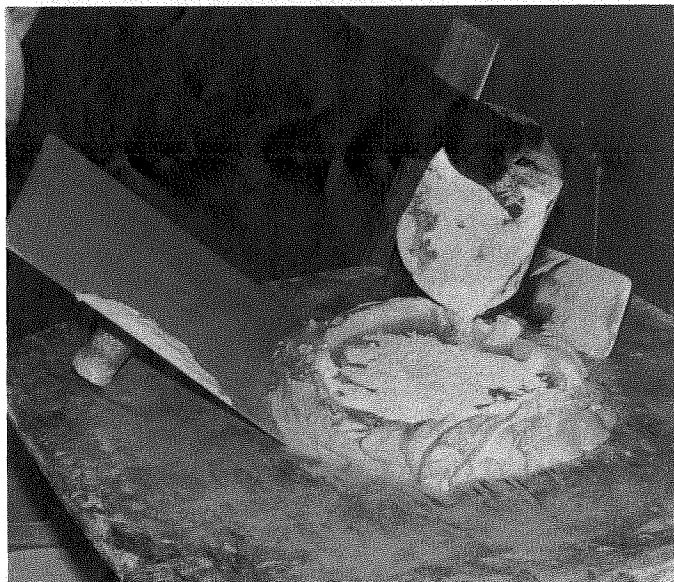
*Fig. 17. This contemporary plasterer is mixing a lime finish coat in much the same way as America's earlier artisans. The ring consists of lime putty; the white powder inside is gauging plaster. After the mixture is blended, a steel trowel will be used to apply it. It should be noted that a traditional lime finish coat can be applied over a veneer plaster base coat to approximate the look of historic plaster walls and ceilings. Photo: Marylee MacDonald.*

The system uses gypsum-core panels that are the same size as drywall (4x8 feet), and specially made for veneer plaster. They can be installed over furring channels to masonry walls or over old wood lath walls and ceilings. Known most commonly as "blueboard," the panels are covered with a special paper compatible with veneer plaster. Joints between the 4-foot wide sheets are taped with fiberglass mesh, which is bedded in the veneer plaster. After the tape is bedded, a thin, 1/16-inch coat of high-strength veneer plaster is applied to the entire wall surface. A second veneer layer can be used as the "finish" coat, or the veneer plaster can be covered with a gauged lime finish-coat—the same coat that covers ordinary plaster (Fig. 17).

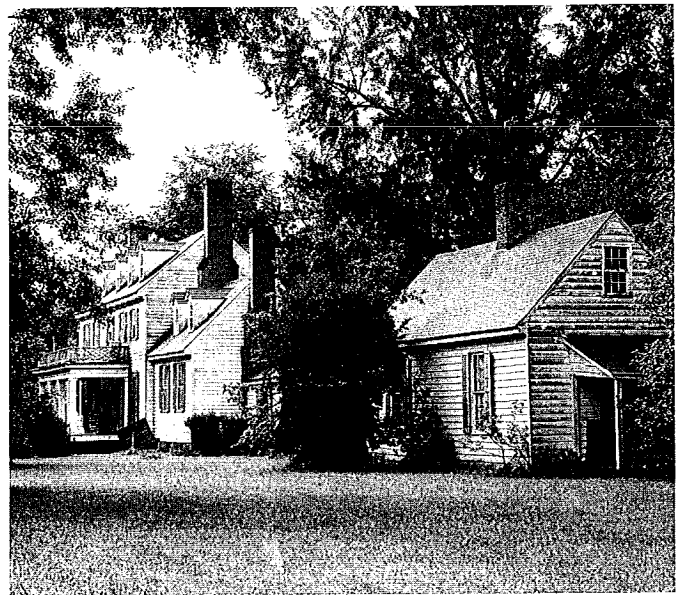
1. Eighteenth century and later vernacular architecture depended on the siting of the building, deciduous trees, cross ventilation, and the placement of windows and chimneys to maximize winter heating and natural summer cooling. Regional details, as seen in this Virginia house, include external chimneys and a separate summer kitchen to reduce fire risk and isolate heat in the summer. Photo: NPS Files.

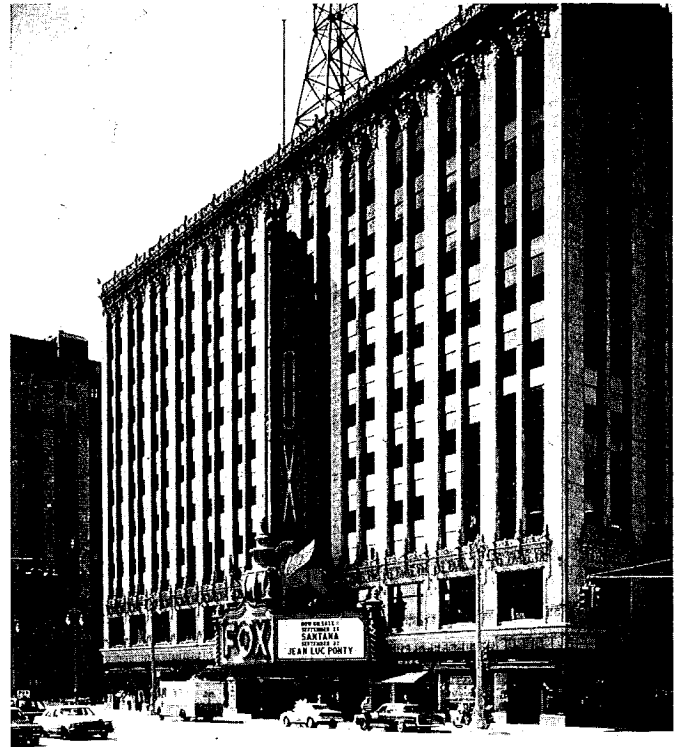
3. The circa 1928 Fox Theater in Detroit, designed by C. Howard Crane, was one of the earliest twentieth century buildings to provide air conditioning to its patrons. The early water-cooled system was recently restored. Commercial and highrise buildings of the twentieth century were able, mostly through electrical power, to provide sophisticated systems that integrated many building services. Photo: William Kessler and Associates, Architects.
